**Sample
Ultrasonic Leak Detection Survey
May 2024**

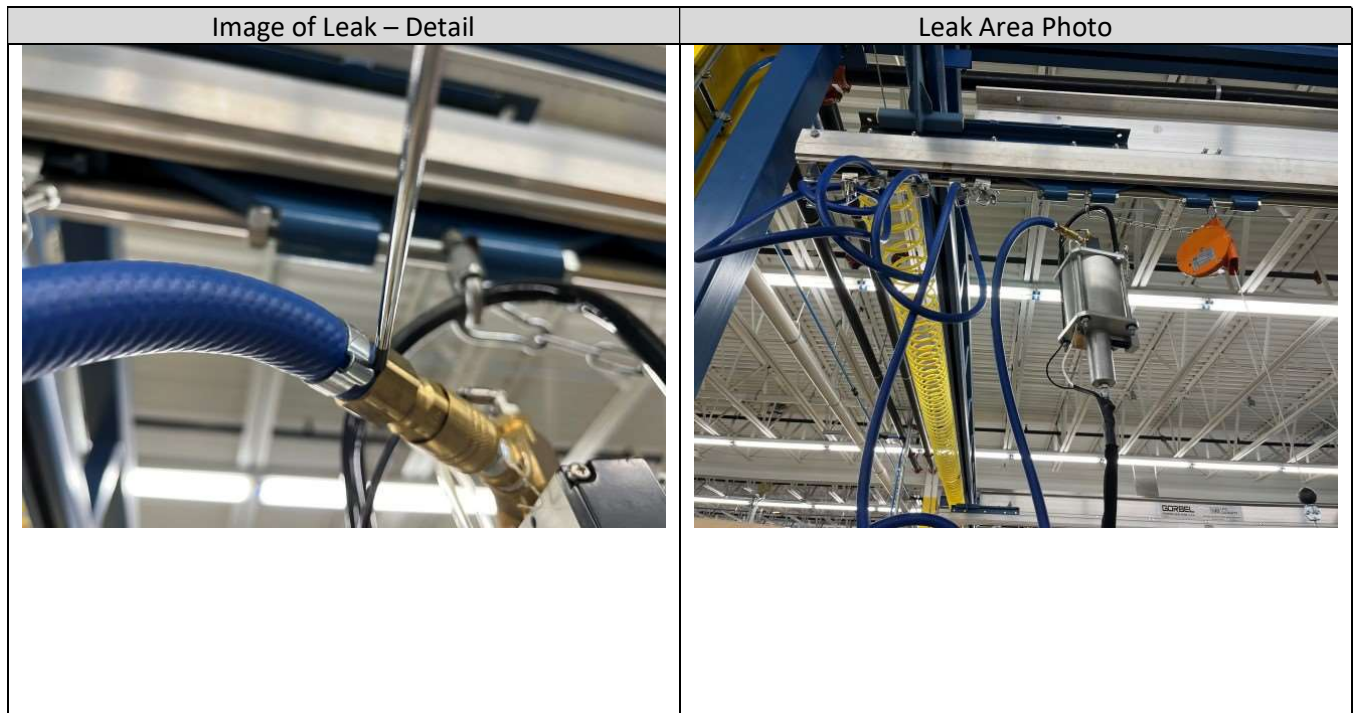
Digital Image of Leak Location

Problem Number	8239
Department	Sample
Location Description	North Clinching Cell by column E2
Type of Gas	Air
System Pressure	100
Ultrasonic Probe – reading (in db)	88.0 DB
Problem Description	Leaking from crimp, 8770, 8771
Repair Status (Yes or not)	N
Work Order Number	
Cost of Leak estimates	\$1150.36
Size of leak (in CFM)	7.4 CFM
KW Savings (kWh)	10,458 kWh
Carbon Footprint Savings (lbs)	18,047 lbs
